Title: Wetland Delineation Report for Middle Mortandad Mesa Adjacent to  
Technical Area 55 at Los Alamos National Laboratory

July 2021

# **Wetland Delineation Report for Middle Mortandad Mesa Adjacent to Technical Area 55 at Los Alamos National Laboratory**

Prepared by Jesse Berryhill, Brent Thompson, Faith Doty, and Alethea Banar  
Environmental Protection and Compliance Division,  
Los Alamos National Laboratory

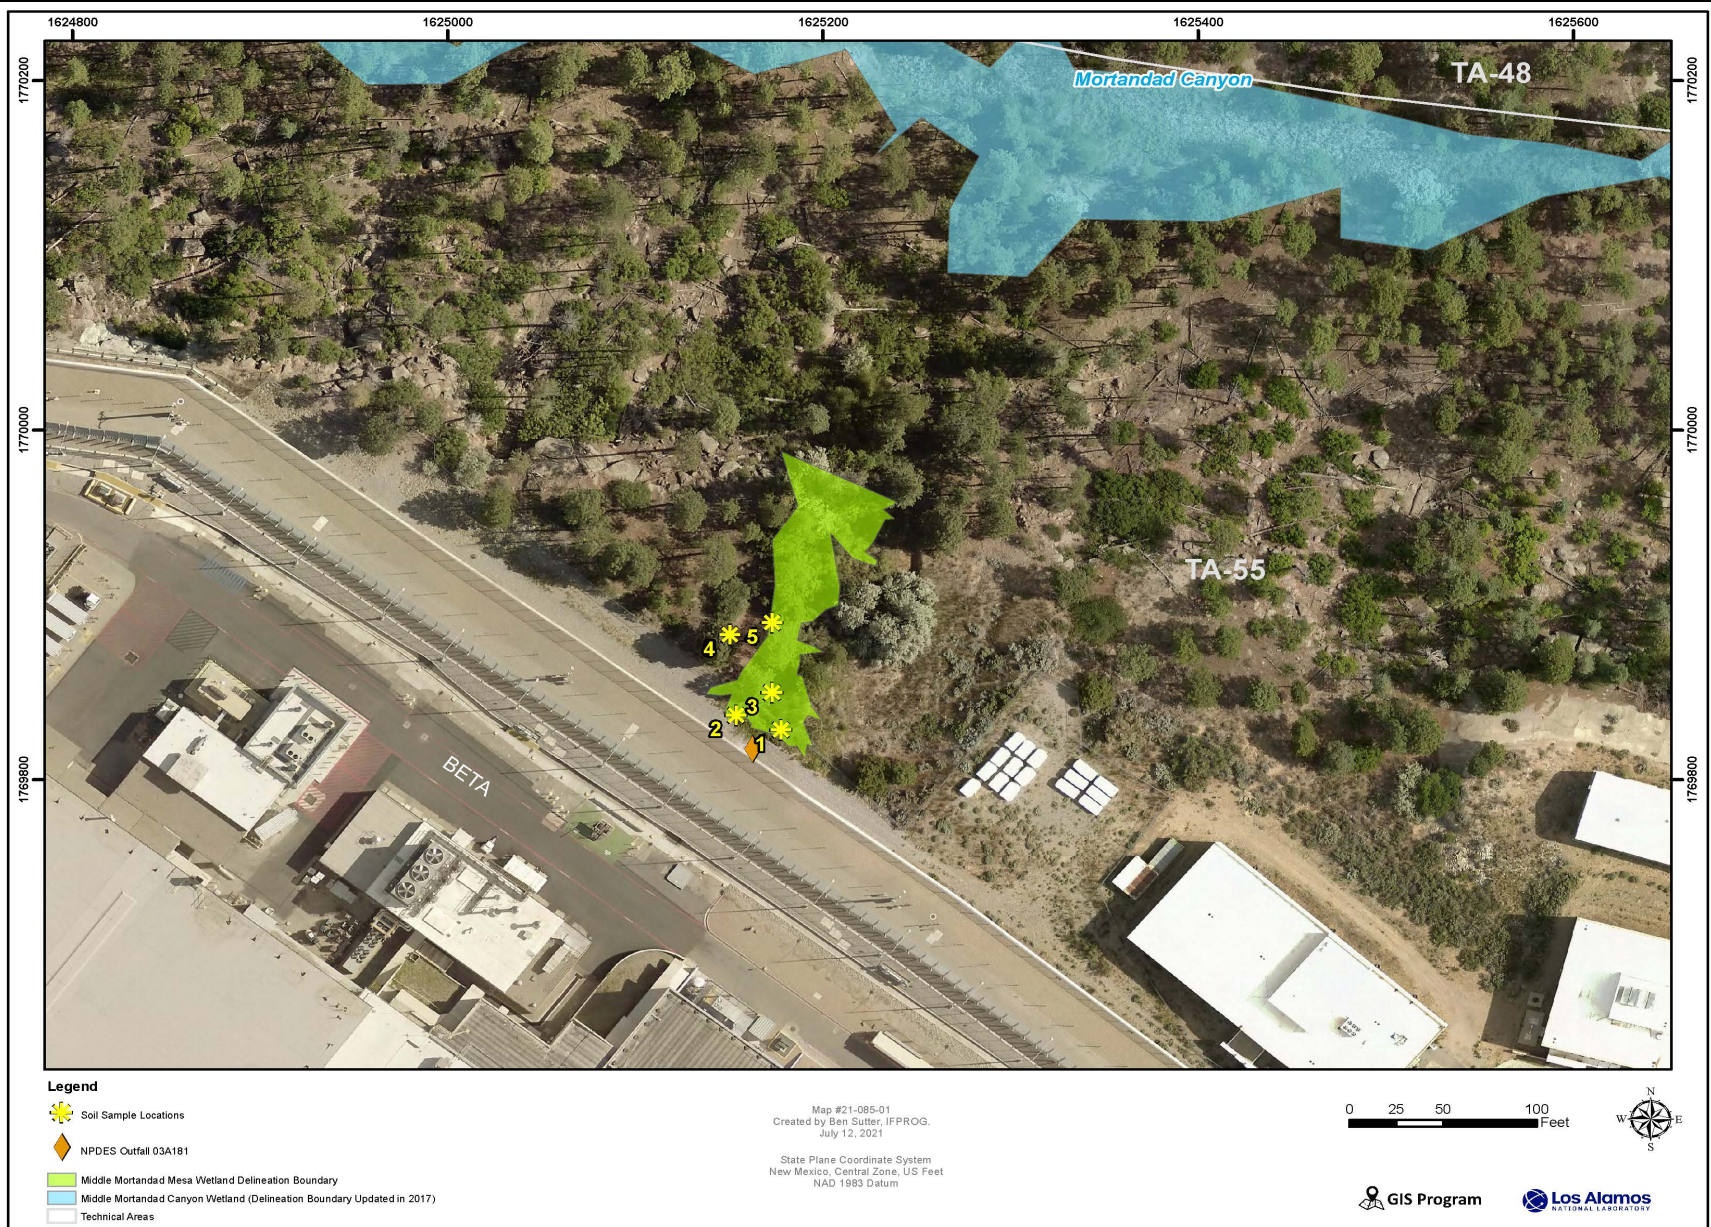
Figure 1. Wetland Delineation Map.

The wetland area is approximately 0.13 acres in size (Figure 1). This area has not been previously delineated; however, it drains north to Mortandad Canyon bottom where LANL updated a delineation in 2017 for the wetland adjacent to Technical Areas (TAs) 25, 48, and 55.

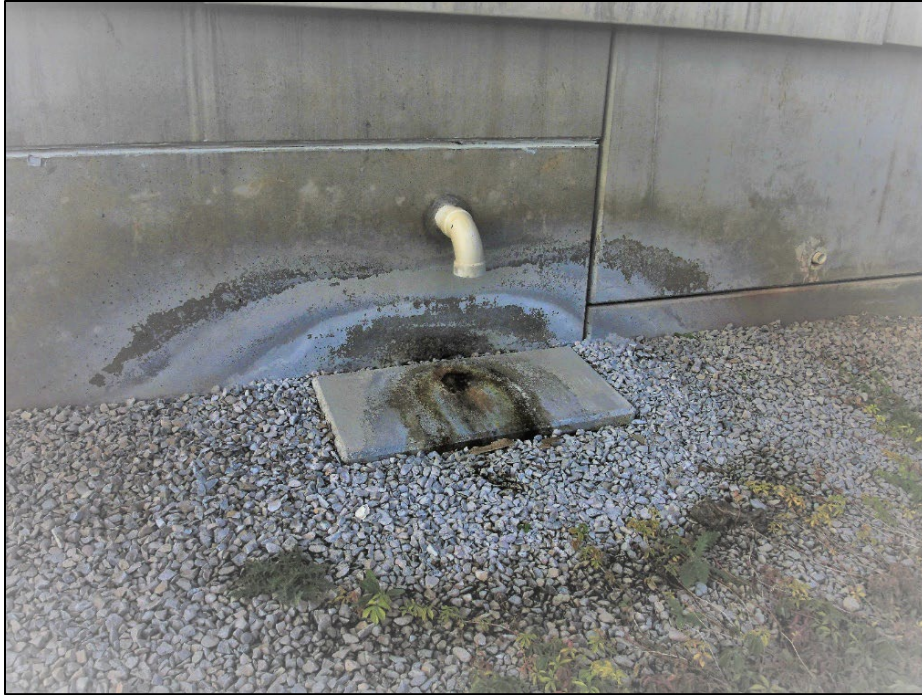
**Figure 2. NPDES Outfall 03A181.**

Hydrology is active and evident; however, the source is manmade. The water consists of treated cooling tower blowdown originating from TA-55 NPDES Outfall 03A181 (LANL 2019) (Figure 1). Flow is intermittent from a pipe near the southern edge of the wetland (Figure 2) with daily discharges that range from 2 to 3.5 million gallons per year. Water flows from the outfall through an area of base course and disperses into several braided channels flowing to the north and to the canyon edge. If changes were made to the current outfall such as rerouting water to another facility, reuse, or discharge to a different outfall, the wetland would no longer receive water beyond local average annual precipitation (approximately 18.79 inches/year).

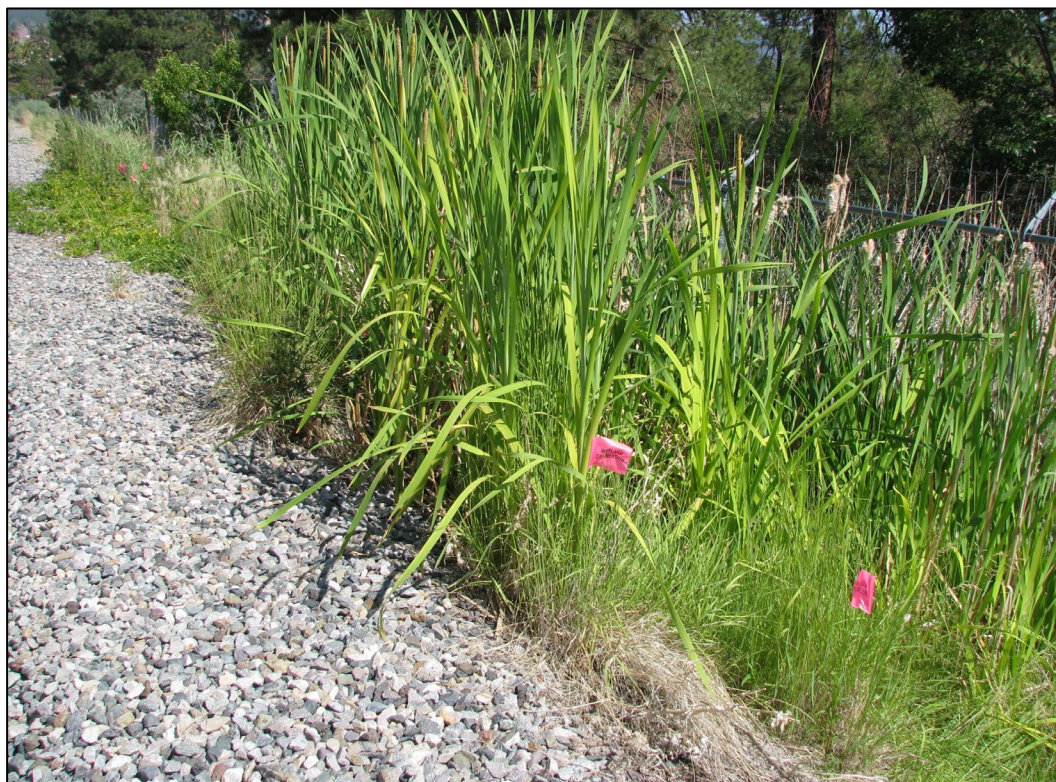
**Photo 1. Sample point 1, view east to west.**

2. <u>Epilobium spp.</u>	<u>5</u>	No	FACW	
3. _____				
4. _____				
Total Cover: <u>95</u> %				
Woody Vine Stratum				
1. _____				
2. _____				
Total Cover: _____ %				
% Bare Ground in Herb Stratum <u>0</u> % % Cover of Biotic Crust <u>0</u> %				
Remarks: Dense cattail dominated location, surface water moving throughout.

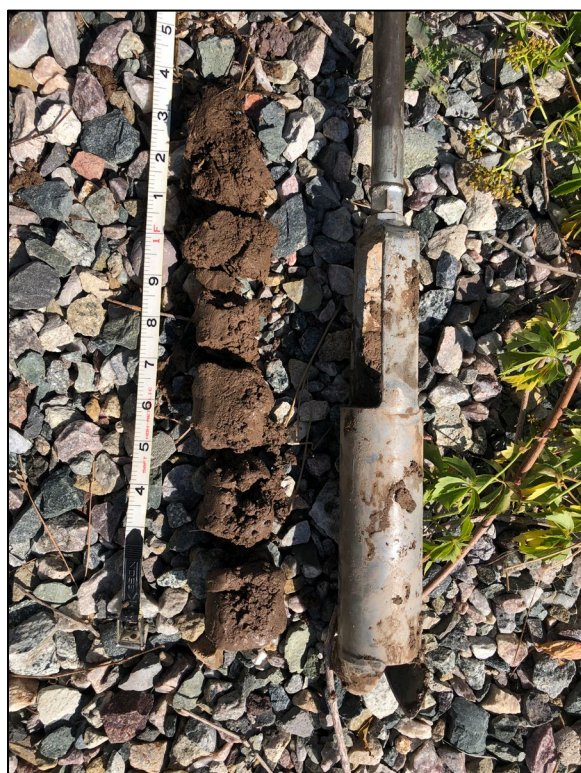
**Photo 2. Soil Sample at Sample Point 1.**

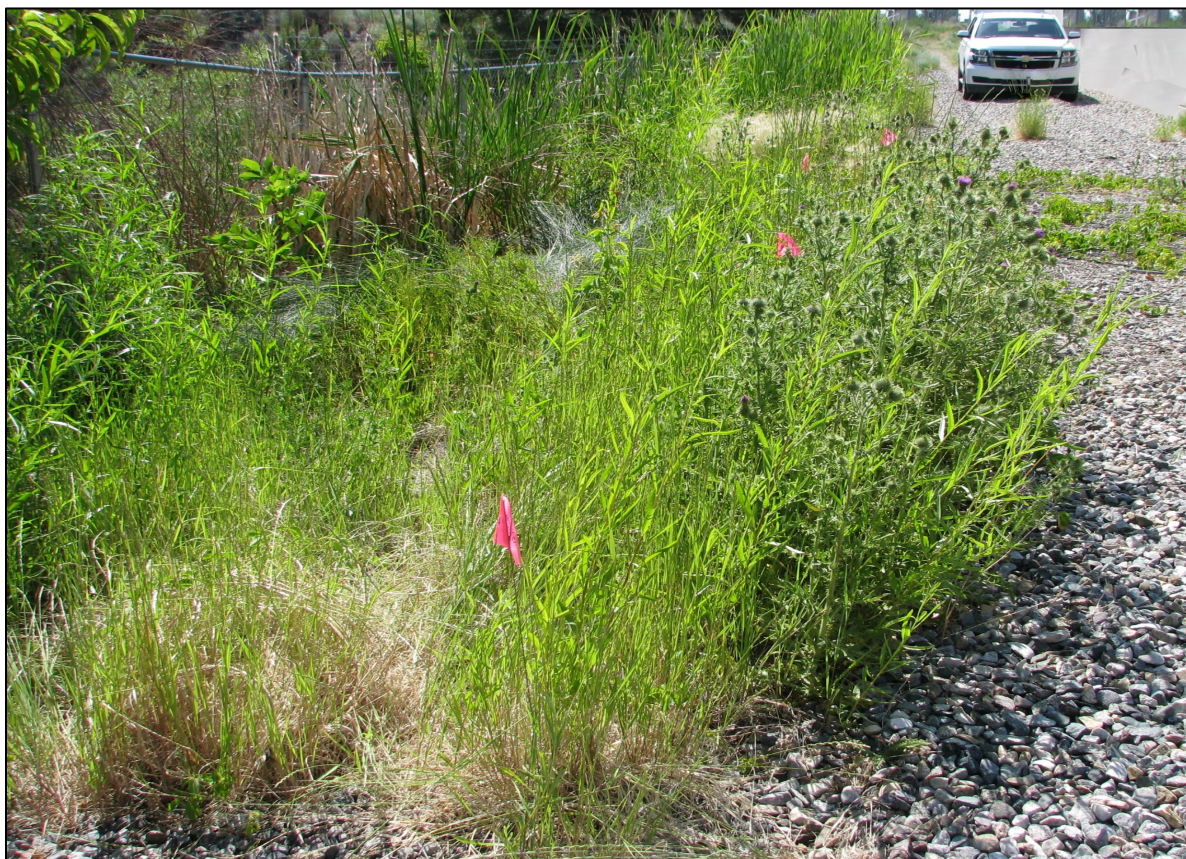
**Photo 3. Sample point 2, view west to east.**

Prevalence Index = B/A = 1.78	Total % Cover of:	Multiply by:		OBL species 25	x 1 =	25	FACW species 72	x 2 =	144	FAC species 3	x 3 =	9	FACU species	x 4 =	0	UPL species	x 5 =	0	Column Totals: 100 (A)		178 (B)
Total % Cover of:	Multiply by:																								
OBL species 25	x 1 =	25																							
FACW species 72	x 2 =	144																							
FAC species 3	x 3 =	9																							
FACU species	x 4 =	0																							
UPL species	x 5 =	0																							
Column Totals: 100 (A)		178 (B)																							
2.																									
3.																									
4.																									
5.																									
Total Cover: 5 %																									
<b>Herb Stratum</b>																									
1. <i>Typha latifolia</i>	20	No	OBL	<b>Hydrophytic Vegetation Indicators:</b> <input checked="" type="checkbox"/> Dominance Test is >50% <input checked="" type="checkbox"/> Prevalence Index is ≤3.0 <sup>1</sup> <input type="checkbox"/> Morphological Adaptations <sup>1</sup> (Provide supporting data in Remarks or on a separate sheet) <input type="checkbox"/> Problematic Hydrophytic Vegetation <sup>1</sup> (Explain)																					
2. <i>Epilobium spp.</i>	10	No	FACW																						
3. <i>Carex scoparia</i>	60	Yes	FACW																						
4. <i>Agrostis gigantea</i>	2	No	FACW																						
5.																									
6.																									
7.																									
8.																									
Total Cover: 92 %																									
<b>Woody Vine Stratum</b>																									
1. <i>Parthenocissus quinquefolia</i>	3	No	FAC	<sup>1</sup> Indicators of hydric soil and wetland hydrology must be present.																					
2.																									
Total Cover: 3 %																									
% Bare Ground in Herb Stratum 0 %	% Cover of Biotic Crust 0 %	<b>Hydrophytic Vegetation Present?</b> Yes <input checked="" type="radio"/> No <input type="radio"/>																							
Remarks: Densely vegetated location with no tree component and saturated soils. Surface water not present.

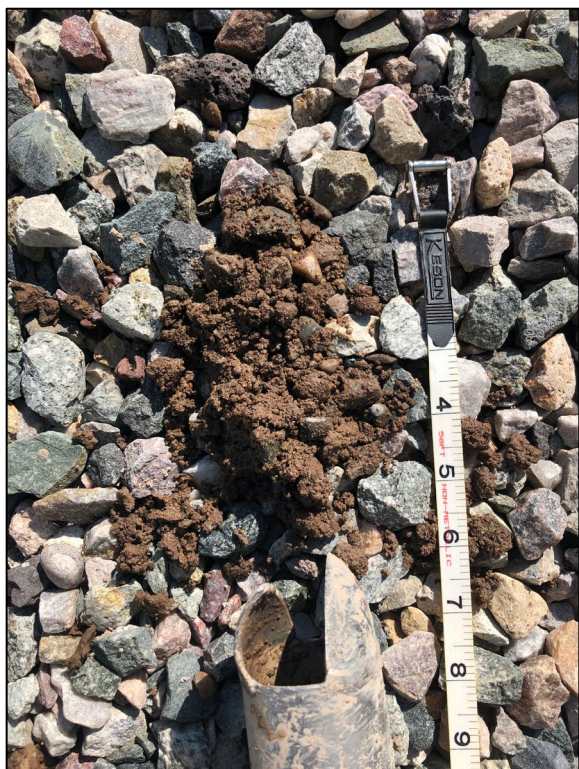
**Photo 4. Soil Sample at Sample Point 2.**

<input type="checkbox"/> Depleted Below Dark Surface (A11) <input type="checkbox"/> Depleted Dark Surface (F7)							
<input type="checkbox"/> Thick Dark Surface (A12) <input type="checkbox"/> Redox Depressions (F8)							
<input type="checkbox"/> Sandy Mucky Mineral (S1) <input type="checkbox"/> Vernal Pools (F9)							
<input type="checkbox"/> Sandy Gleyed Matrix (S4)							
<sup>4</sup> Indicators of hydrophytic vegetation and wetland hydrology must be present.							
<b>Restrictive Layer (if present):</b>							
Type: Cobble/large gravel							
Depth (inches): 27 inches							
Hydric Soil Present? Yes <input type="radio"/> No <input checked="" type="radio"/>							
Remarks: Saturated throughout, no redox features/gley/iron or otherwise, chunks of saturated tuff and other porous overburden that were breaking down, approx 24-in water table/refill depth, sandy throughout, clay or organic matter increasing w/ depth but not at a significant texture percentage- just enough to hold the soil bore together.

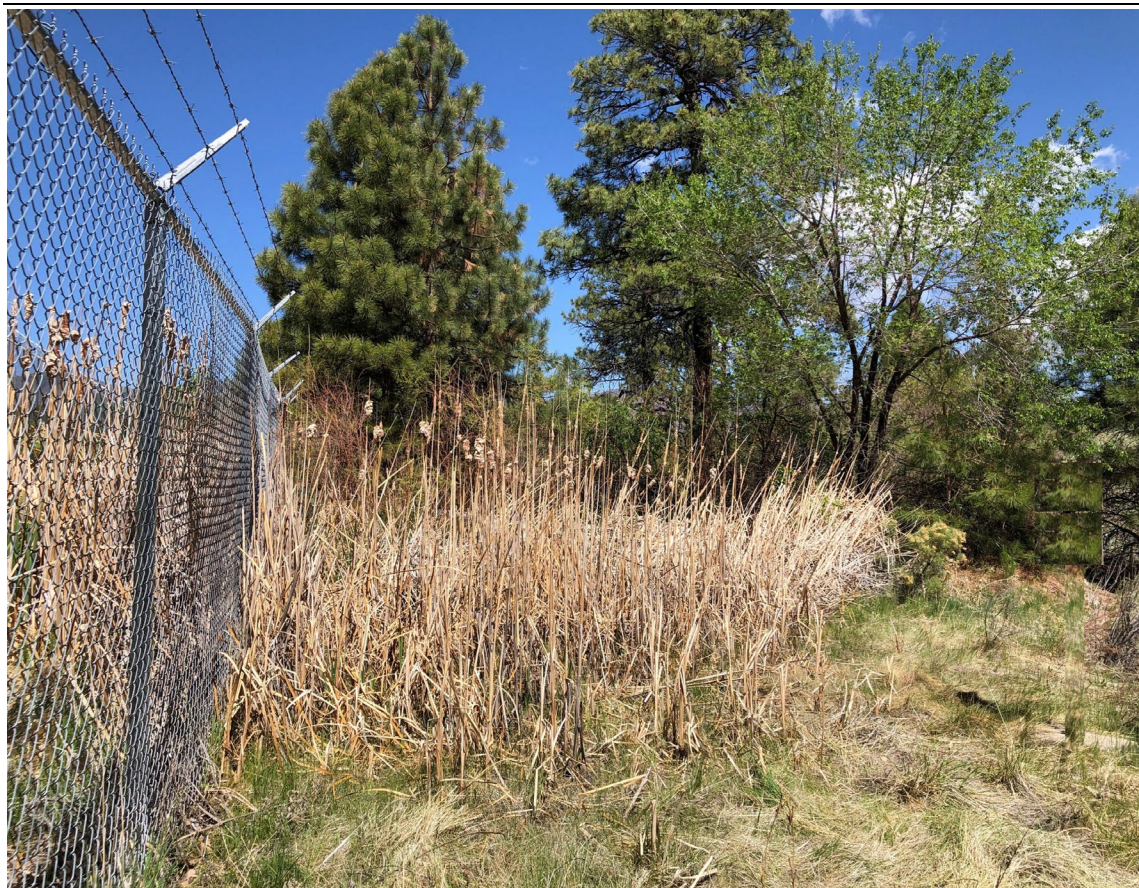
**Photo 5. Sample point 3 outside the fence, view east to west.**

Prevalence Index = B/A = 1.00	Total % Cover of:	Multiply by:	OBL species 100	x 1 = 100	FACW species	x 2 = 0	FAC species	x 3 = 0	FACU species	x 4 = 0	UPL species	x 5 = 0	Column Totals: 100 (A)	100 (B)
Total % Cover of:	Multiply by:																	
OBL species 100	x 1 = 100																	
FACW species	x 2 = 0																	
FAC species	x 3 = 0																	
FACU species	x 4 = 0																	
UPL species	x 5 = 0																	
Column Totals: 100 (A)	100 (B)																	
Sapling/Shrub Stratum																		
1.																		
2.																		
3.																		
4.																		
5.																		
Total Cover: %																		
Herb Stratum																		
1. <i>Typha latifolia</i>	100	Yes	OBL															
2.																		
3.																		
4.																		
5.																		
6.																		
7.																		
8.																		
Total Cover: 100%																		
Woody Vine Stratum																		
1.																		
2.																		
Total Cover: %																		
% Bare Ground in Herb Stratum 0 %	% Cover of Biotic Crust 0 %																	
<b>Hydrophytic Vegetation Present?</b> Yes <input checked="" type="radio"/> No <input type="radio"/>																		
<b>Hydrophytic Vegetation Indicators:</b> <input checked="" type="checkbox"/> Dominance Test is >50% <input checked="" type="checkbox"/> Prevalence Index is $\leq 3.0^1$ <input type="checkbox"/> Morphological Adaptations <sup>1</sup> (Provide supporting data in Remarks or on a separate sheet) <input type="checkbox"/> Problematic Hydrophytic Vegetation <sup>1</sup> (Explain) <sup>1</sup> Indicators of hydric soil and wetland hydrology must be present.																		
Remarks: Dense cattail dominated stand.

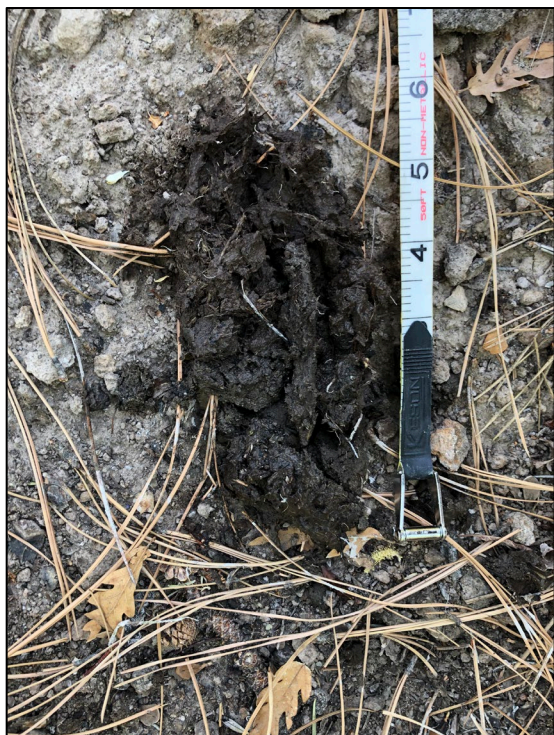
**Photo 6. Soil Sample at Sample Point 3.**

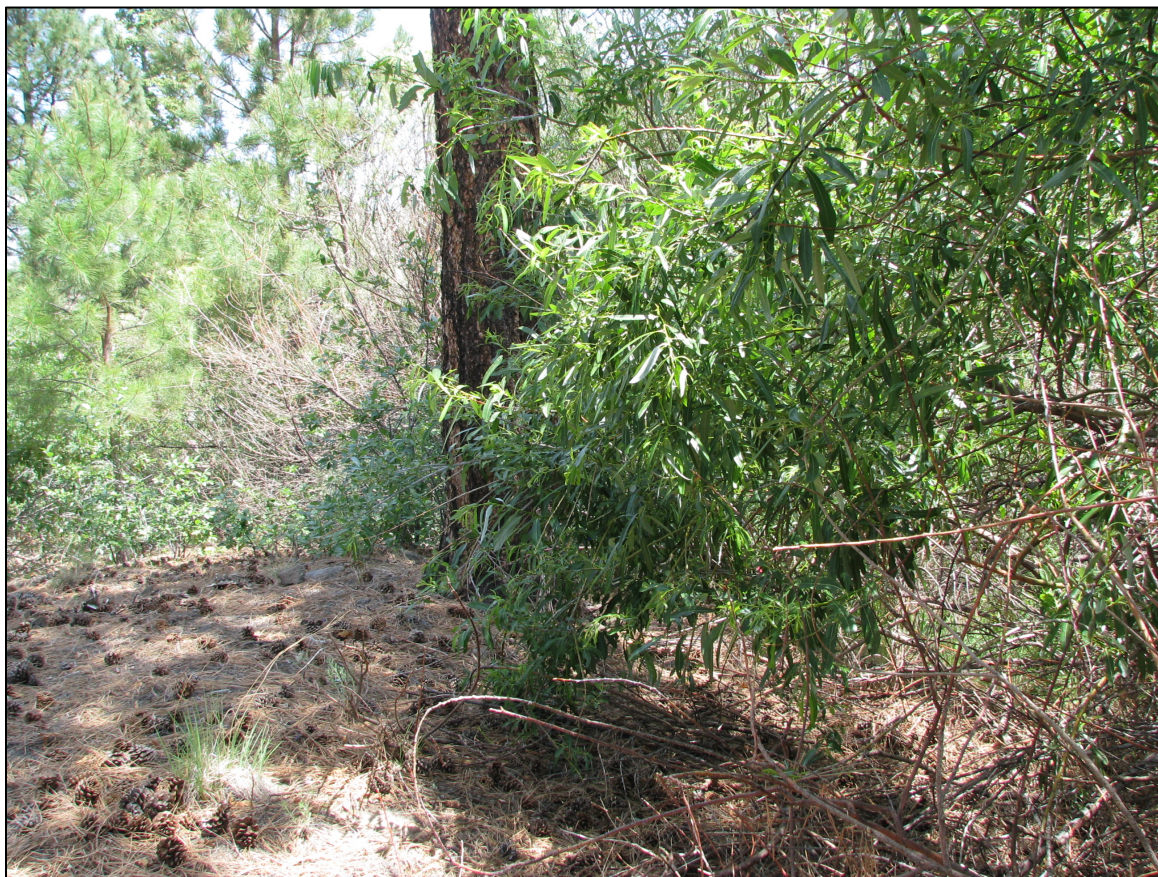
**Photo 7. Sample Point 4, looking north**

1. <i>Agrostis gigantea</i>	8	Yes	FACW	Remarks: Sample point 4 is located in an upland area to the west of the wetland area. Wetland boundary identified based on vegetation, soils and hydrology present.

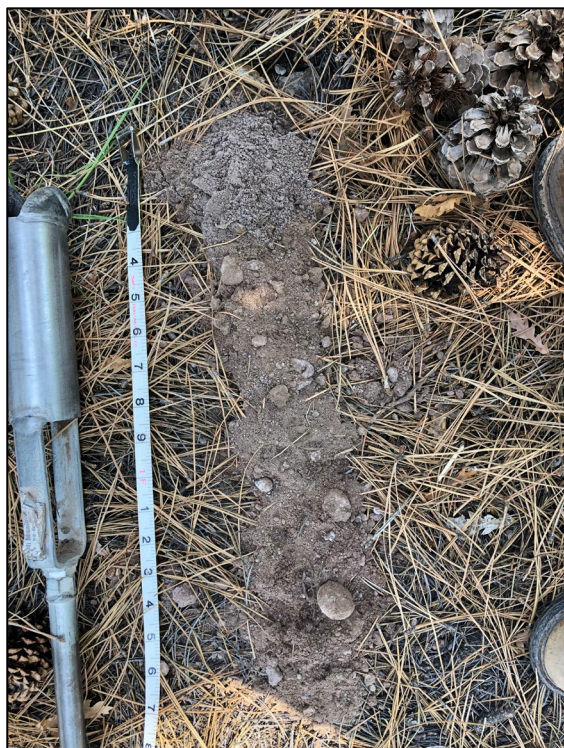
**Photo 8. Soil Sample at Sample Point 4.**

Remarks: 1-inch approximate layer of duff, some tuff outcroppings less than 4-ft from soil pit, dry. 6-7 inches to bedrock, uniform throughout, sandy and gritty, gravel/grit from birdseed size to grape-sized, some pine needles in top 2-3 inches, dry/no structure, soil fell apart once removed, sediments felt similar to those within the wetlands-but dry and lacking organic matter

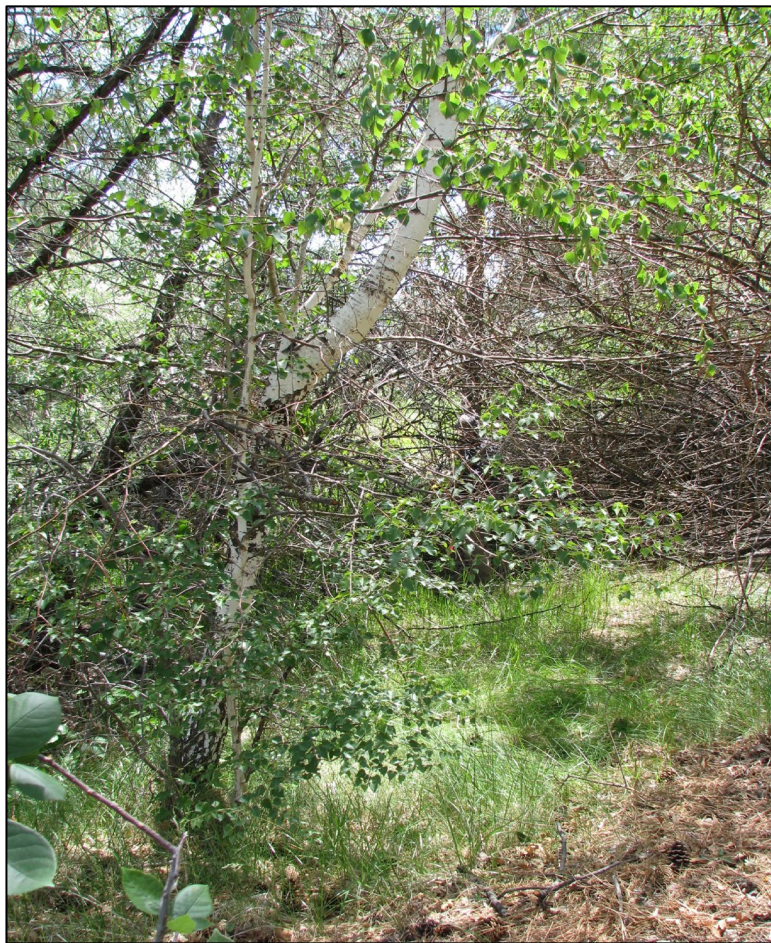
**Photo 9. Sample Point 5, view west to east**

Remarks: Shaded and open understory, lacking hydrophytic herb/forb component, surface water flowing throughout.

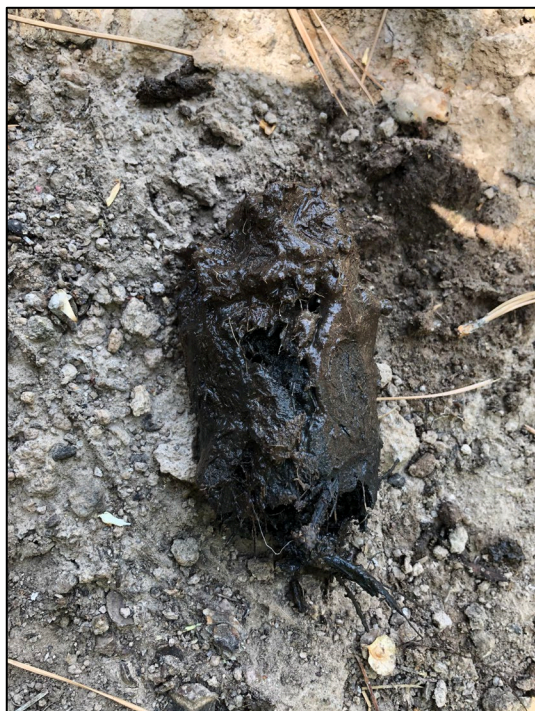
**Photo 10. Soil Sample at Sample Point 5**
